Access to the Beehive Centre by cyclists and pedestrians

This letter is a short summary of our findings, in the form of a ten-step plan of simple, practical points, to improve considerably access to the Centre, which we hope you will be able to pass on and follow up locally. We would be very willing to discuss these with you, on-site.

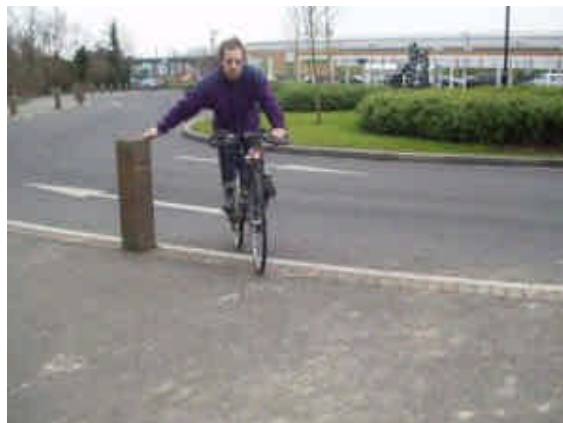
1. Getting from the pathway on to the road

This would be especially helpful for cyclists heading towards ASDA. At present the nasty 'bump' is unpleasant and is difficult for those with shopping.

Action: simply install a flush ("dropped") kerb so that cyclists can join the road, at the location shown in the photograph.

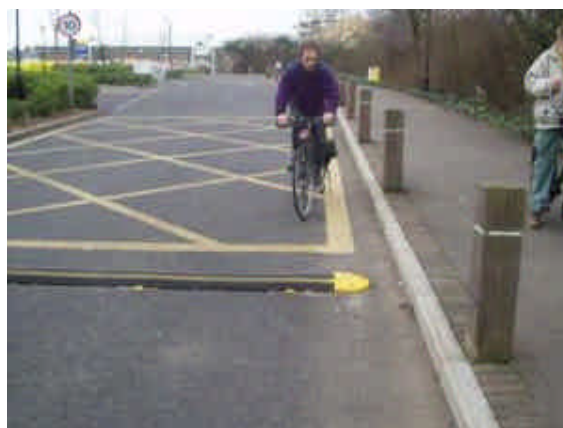
2. Speed humps

These are so dangerous for motorists and cyclists that they would be illegal on a public road. Cyclists, for instance, could be thrown off their bike, especially laden with shopping.

Please would you reduce the length of each hump to leave a 'cycle gap' either side. This is very common practice in highway engineering. The humps are still effective in slowing motor traffic.

Action: shorten each of the humps.

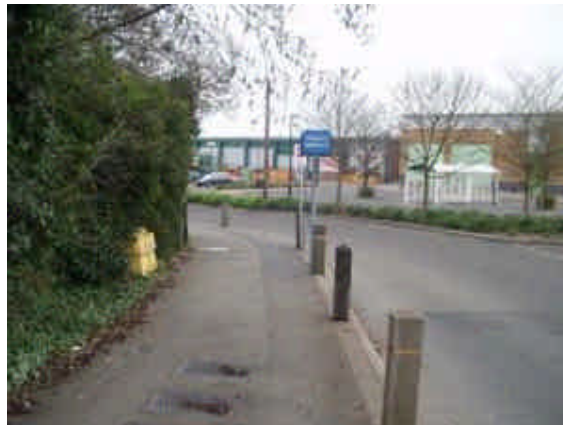
3. Two obsolete 'cyclists dismount' signs

There are two signs (as in the picture and nearer the main entrance) which both appear to be unnecessary relics from previous years and which simply create confusion to motorists and cyclists alike.

Action: remove the two signs and their posts.

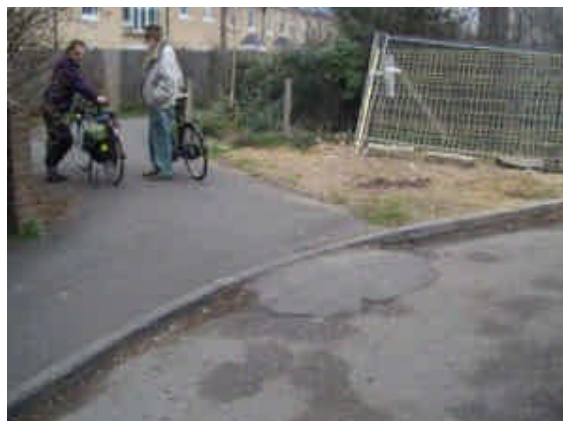
4. Provision of a proper ramp to the entrance to the site by York Street.

This would be especially helpful for the many cyclists who will be carrying heavy shopping and would reduce pedestrian/cyclist conflict.

Action: install a flush ("dropped") kerb at the location shown.

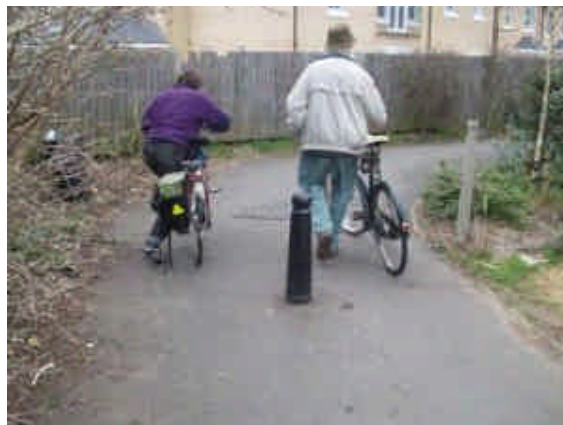
5. The bollard by the York Street entrance.

This bollard is placed in a rather hazardous location because of the blind corner and the overgrown vegetation: many people using the site may not see it. Partly this is due to the lack of lighting, which in itself may be a personal security issue.

Action: remove the bollard (or at least add a reflector to it and move it around 2m towards the Centre) and improve the lighting.

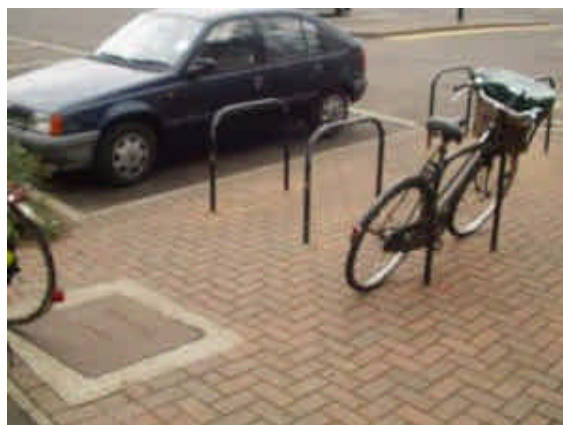
6. Ramp from the pathway on to the road near the furniture shop

This would be especially helpful for cyclists using the shops to the right of ASDA.

Action: install a flush (“dropped”) kerb so that cyclists can join the road / car park area, near the pine furniture shop (to the right of the area shown in the picture).

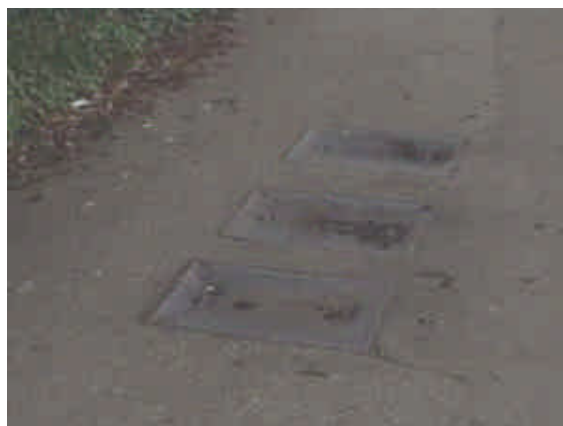
7. Uneven ironwork on the pathway

The drain covers on the pavement could cause pedestrians or cyclists to slip or trip, as they are very uneven.

Action: replace these drainage covers so that the surface becomes smooth again.

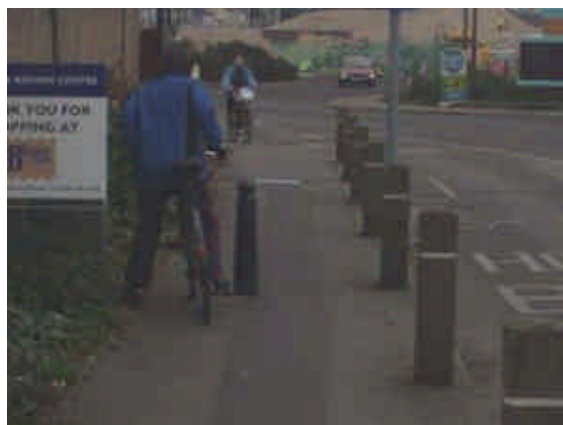
8. Bollard near the exit

This is an unnecessary obstruction which pedestrians and cyclists could run into. It is unnecessary as no motorist would attempt to drive here.

Action: remove the bollard.

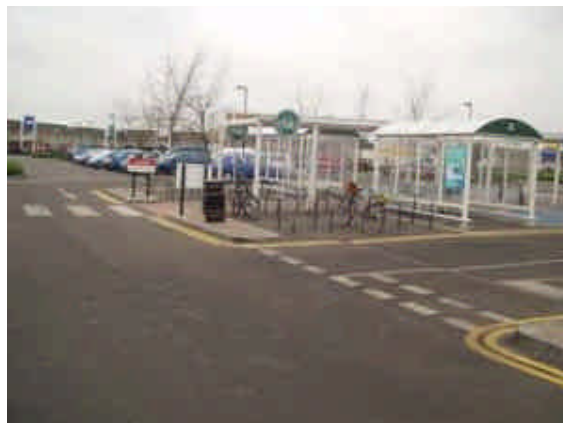
9. Cycle parking near ASDA

We found the quality and level of cycle parking on the site to be good, which is very encouraging. However, some members have noted a lack of available spaces at busy times.

Action: install more cycle parking of the same type as at present, near to the entrance, preferably covered like the trolley areas.

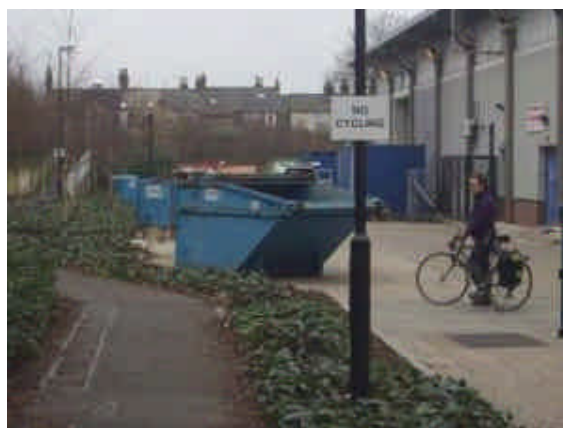
10. 'No cycling' sign at the back entrance/exit adjoining Sleaford Street

As well as a 'no public access' sign nearby, there is a 'no cycling' sign alongside this path, for which there seems no real need.

Both this and the main path have been used as a cycle route for many years, and were described as a cycle route in the planning application for the ASDA store. We met with a representative of British Land at the time who confirmed it would remain a cycle route.

Action: remove the sign.
